SEISMIC DAMAGES IN PIPELINES IN THE LIGHT OF PREVENTIVE MAINTENANCE

Key words: Water Distribution Systems, Earthquake, Christchurch, Breaks, Leaks

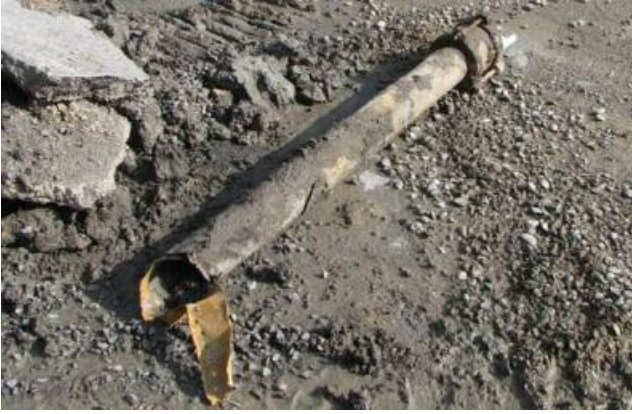
a) DN 100 (4") spiral riveted pipe

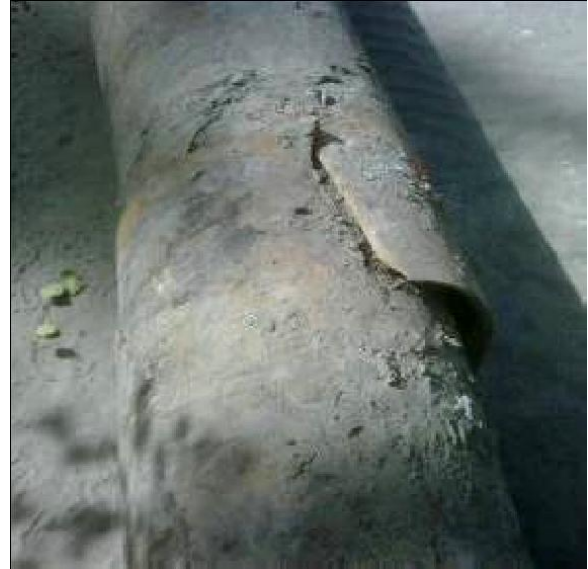
*b) DN 300 (12") CLS (Concrete Lined Steel) Pipe Split
(Photo by P. Free)*

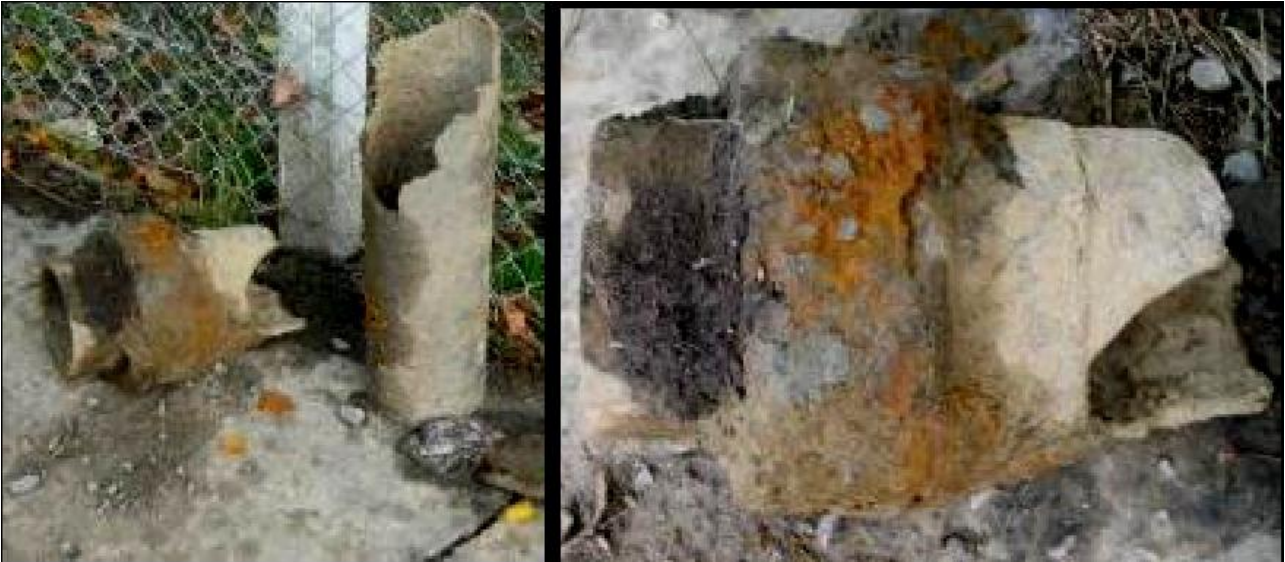
c) Fractured DN 150 (6") CI pipe
