SEISMIC DAMAGES IN PIPELINES IN THE LIGHT OF PREVENTIVE MAINTENANCE

Key words: Water Distribution Systems, Earthquake, Christchurch, Breaks, Leaks

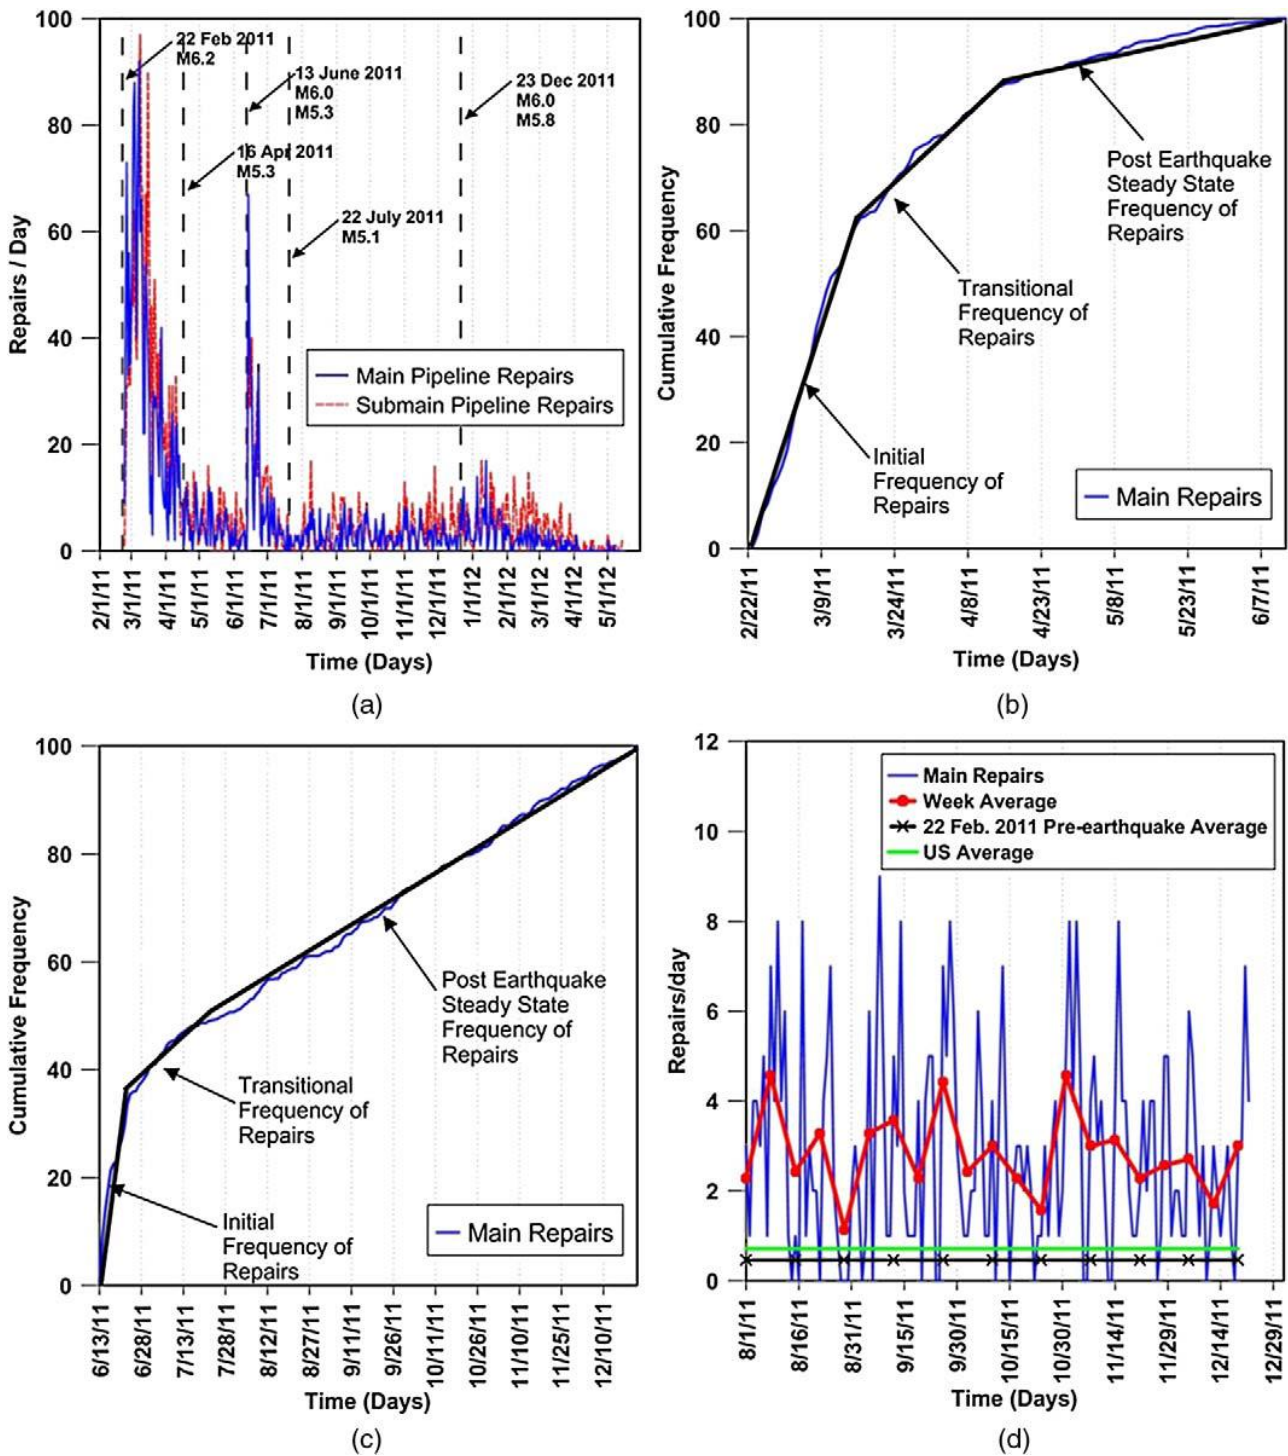
The water supply repair database for Christchurch is composed of continuous daily repair records for return of services covering a long period of Canterbury earthquake sequence (O'Rourke et al., 2012; 2014). The repair records include information on type of repair, location, and time. Figure 1a presents the daily repairs for mains and submains as a function of time. Submains are pipelines with diameters less than 75 mm, which branch off mains to provide water to a limited number of houses. Also shown in the figure are the two large earthquakes and select aftershocks. Figure 1b shows the cumulative frequency of main repairs, defined as cumulative percentage of total repairs, derived from Figure 1a, from the time of the 22 February 2011 earthquake to just before the 13 June 2011 earthquake. It can be seen that the initial frequency of repairs is very high and reduces through a transitional phase to a steady state rate of repair, leading to the 13 June 2011 earthquake. A similar pattern of RRs is shown by the cumulative frequency distribution after the 13 June 2011 earthquake, with initial, transitional and post-earthquake steady state repair conditions identified in Figure 1c.

O'Rourke et al. (2012 and 2014) used the time at the start of the steady state repair conditions as the end of repair activities directly related to the large earthquakes. Several aftershocks during the immediate and steady state repair periods triggered local liquefaction and pipeline repairs, thus contributing to elevated repair rates. Moreover, ongoing repairs to roads and adjacent utilities also disturbed water mains already vulnerable because of main shock events. Hence, the daily repair rates approximately two months after main earthquakes depicted in Figure 1a are above the pre-earthquake average shown in Figure 1d. At some time after one of the large earthquakes, daily repairs will reduce to a rate consistent with aftershock effects as well as post-earthquake construction and associated maintenance requirements, which in this study are linked to steady state conditions. Figure 1d shows the repair rates per day and daily rate (total repairs for each week divided by seven days) for the steady state conditions after the 13 June 2011 earthquake. For comparison, the Christchurch average pre-earthquake (Christchurch City Council, 2006) and average U.S. water distribution system (Bardet et al. 2010) repair rates are shown in the figure. It can be seen that the steady state repair rate after large earthquakes in Christchurch is approximately three to four times greater than RRs not affected by prior earthquakes. This shows the adverse effect of seismic actions on weakening of pipelines or delineating minor damages even in the long term. Black (2013) made similar observations and stated that aside from the major pipe bursts that occurred immediately during the main earthquakes, more subtle damage also occurs and this damage may take weeks, months or years before it shows at the surface. This subtle damage includes leaks at deflected run-lead joints on cast iron (CI) and steel mains, joints on all pipe materials partially pulled out, breakage of CI gibault joints due to poor installation or over deflection due to permanent ground deformation (PGD) Black (2013).

Figure 1. Water distribution repair characteristics with respect to time: (a) Daily main and submain repairs; (b) cumulative frequency of repairs between 22 February and 13 June 2011; (c) cumulative frequency of repairs between 13 June and 23 December 2011; and (d) observation of repairs in post-earthquake steady state stage. (O'Rourke et al. 2012; 2014)

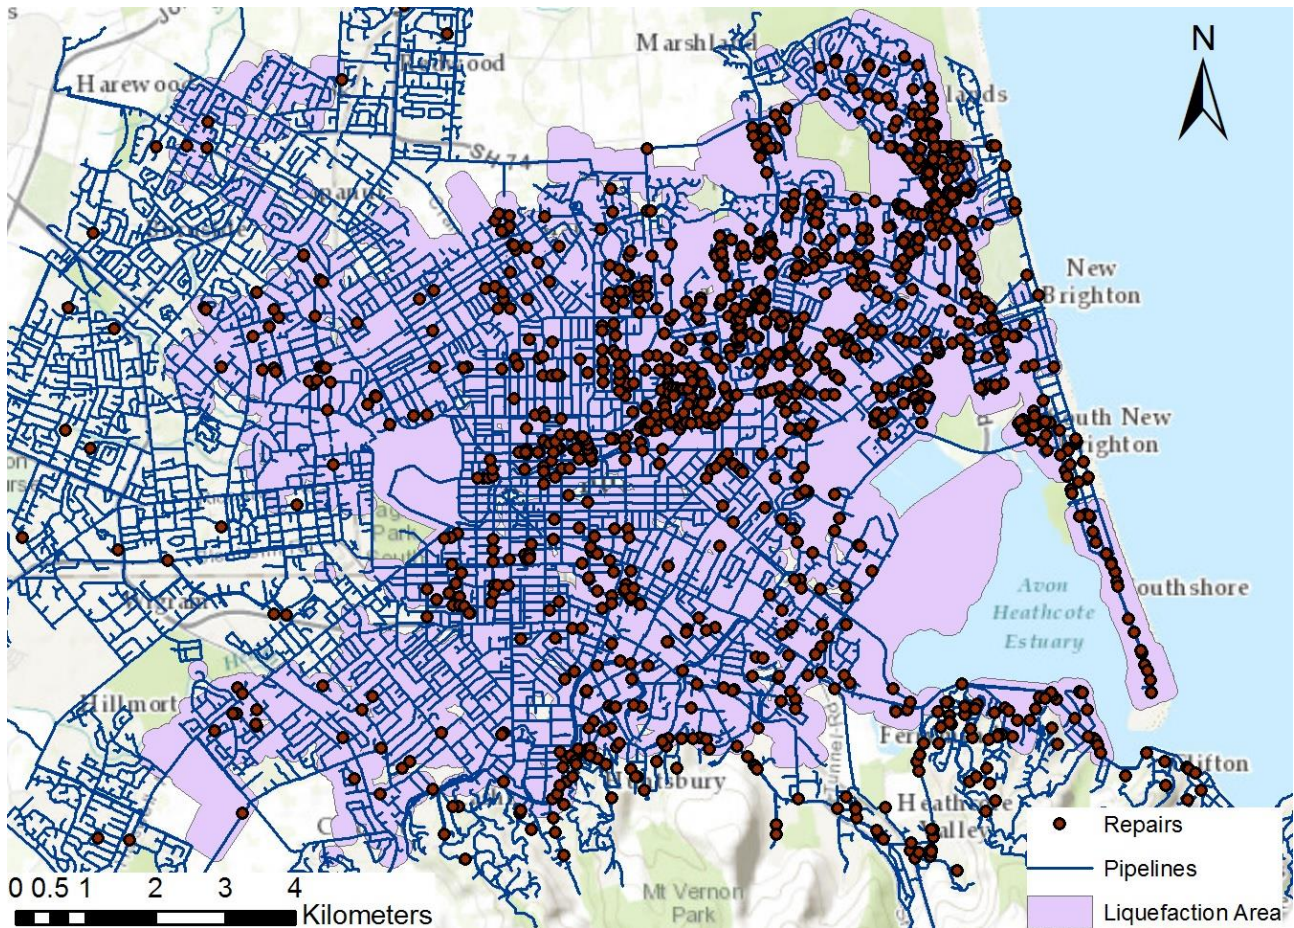
The repair records from Christchurch water supply system for the 22 February 2011 earthquake include information on type of repair, location, and time, but do not always provide enough information to determine if the repair is a leak or a break (loss of continuity due to joint pullout or pipe separation after rupture). The authors of this paper did their best with the existing database to assess the pipe damages according to pipe material type. The focus of the study is the pipeline damages in the liquefaction areas of Christchurch. Figure 2 shows coverage of liquefaction associated with pipeline distribution and repairs for 22 Feb. 2011 earthquake. The damages in liquefaction zones can result from lateral strains or angular distortions in the soil. A comprehensive discussion of the correlations between pipeline damages and lateral strains or angular distortions is available in Toprak, et al. (2014; 2015a) and O'Rourke et al. (2014). The total length of pipelines in liquefaction areas are; 405.7 km asbestos cement (AC), 130.9 km cast iron (CI), 111.9 km polyvinyl chloride (PVC), 48.9 km modified polyvinyl chloride (MPVC) and 141.9 km other types. Figure 3 shows different pipe damages from during Canterbury earthquake sequence.

Figure 2. Pipeline distribution and repairs with liquefaction area for 22 Feb. 2011 earthquake

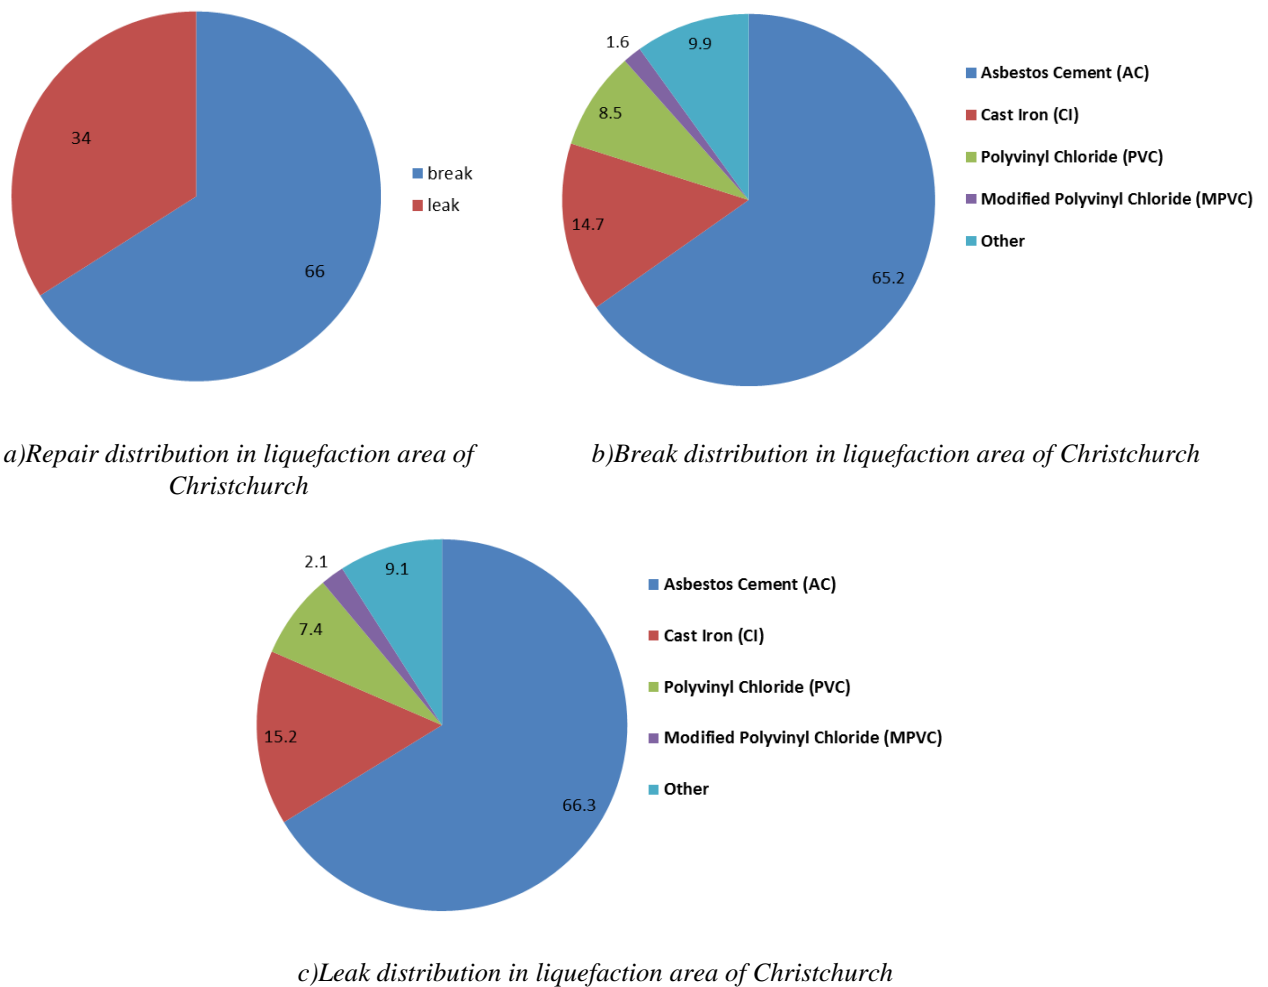
Figure 4a shows the break and leak distribution of the pipeline damages in the liquefaction area. According to the results, almost two thirds and a third of the damages are break and leak, respectively. Figure 4b and 4c show the break and leak distributions, respectively with respect to pipe material. According to analysis of the damage database, CI and AC pipelines have similar rates of breaks and leaks. Their rates are consistent with the rates for all pipelines, which is almost two thirds and a third of the damages are break and leak, respectively.

Figure 4. Repair (Break and Leak) distribution in liquefaction area of Christchurch
