Conference Paper · January 2017

## PIPELINE DAMAGE PREDICTIONS IN LIQUEFACTION ZONES USING LSN

### Abstract

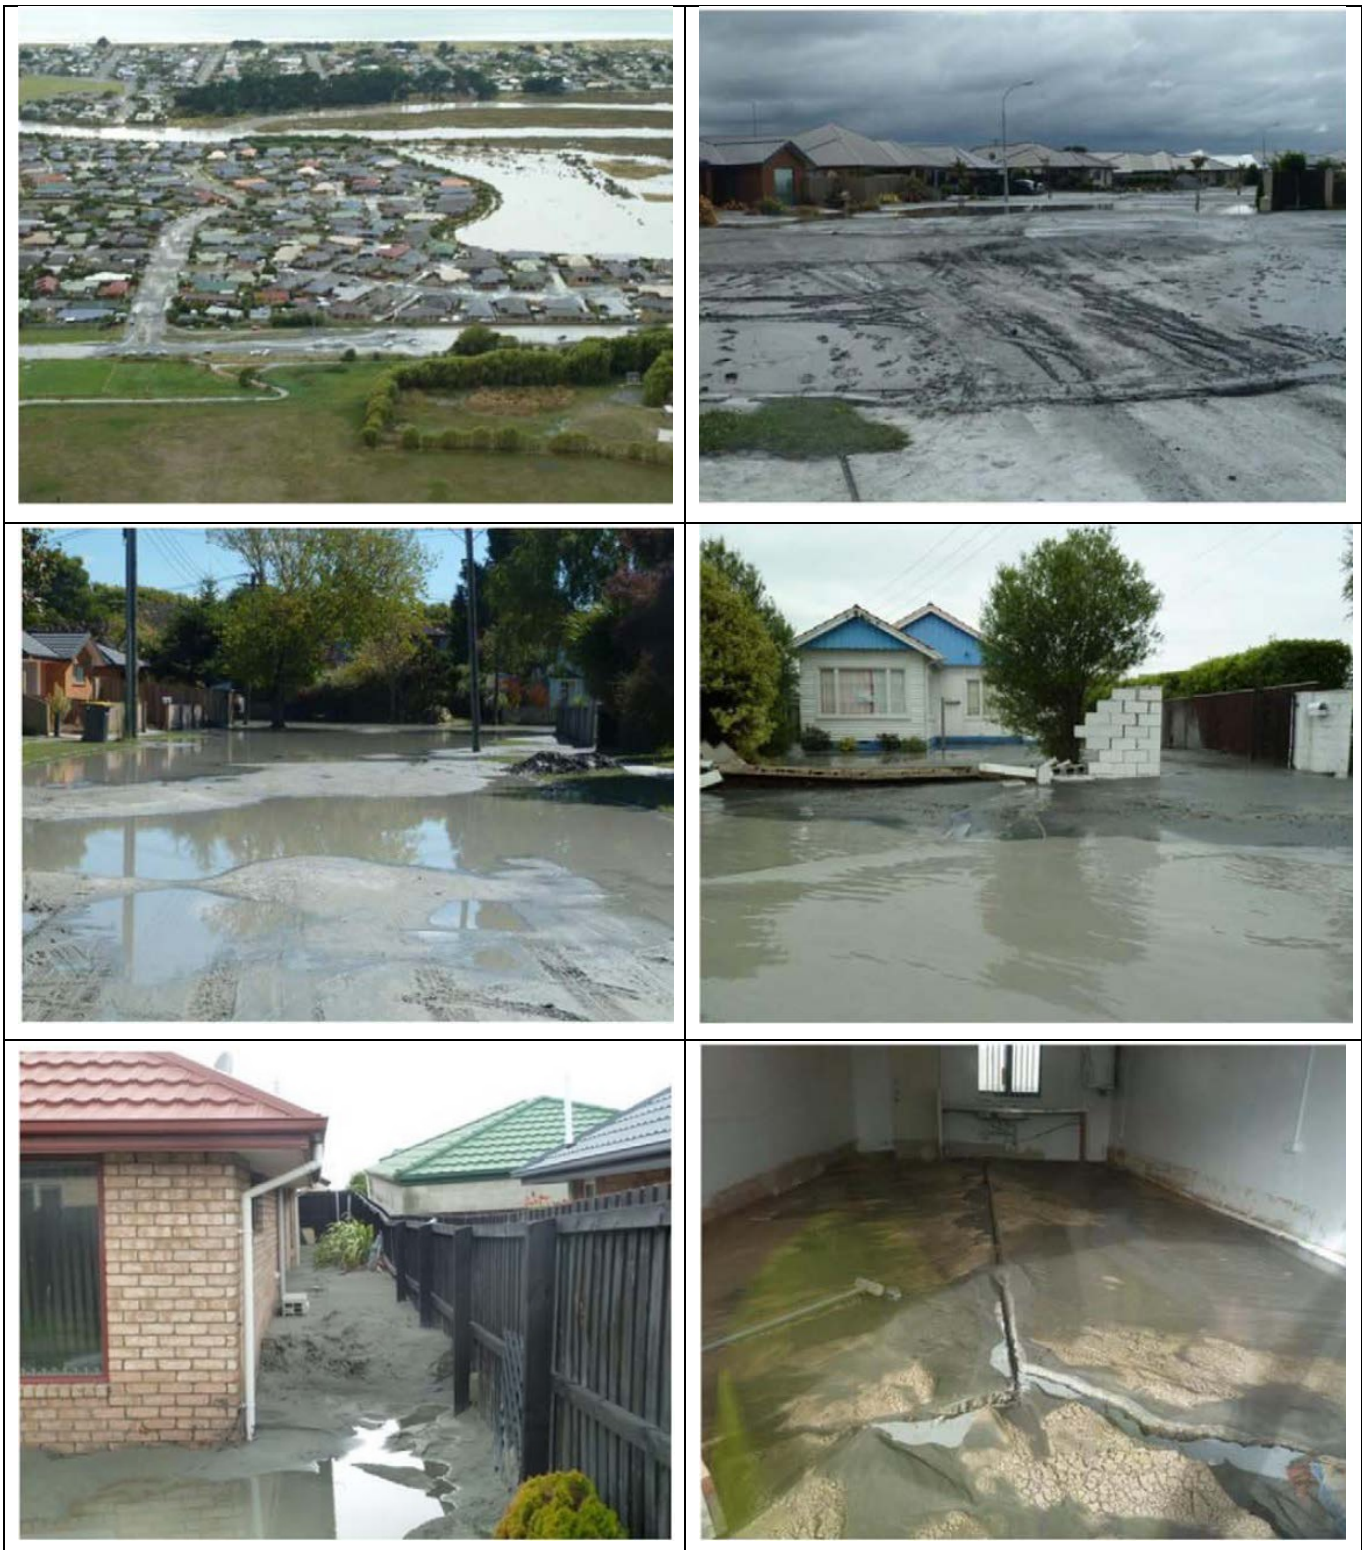
Fig. 1 Observed liquefaction related land damage and residential house damage in Christchurch following the CES [3]

During the 2010 to 2011 Canterbury Earthquake Sequence (CES), Christchurch infrastructure was affected by severe liquefaction with large PGD levels. Fig. 1 shows observed liquefaction related land damage and residential house damage in Christchurch following the CES [3]. In addition to land residential housing

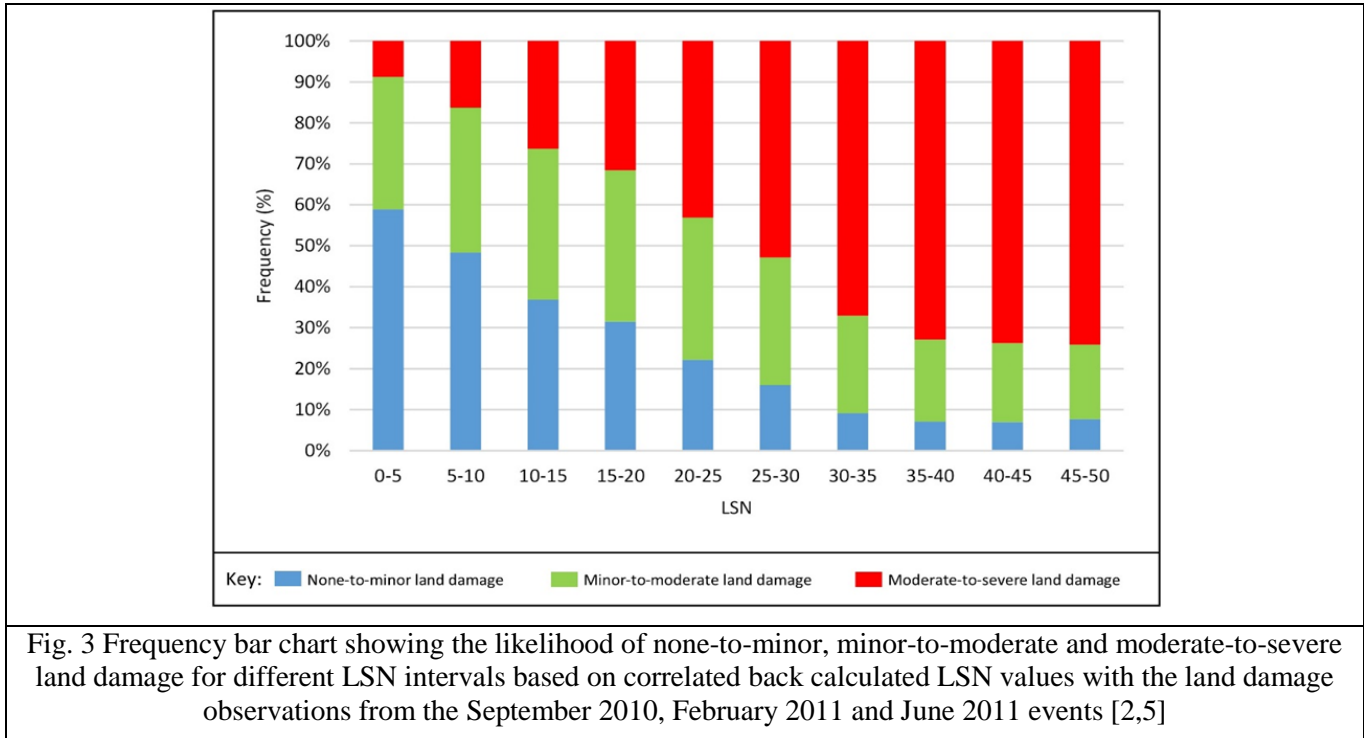
Fig. 3 Frequency bar chart showing the likelihood of none-to-minor, minor-to-moderate and moderate-to-severe land damage for different LSN intervals based on correlated back calculated LSN values with the land damage observations from the September 2010, February 2011 and June 2011 events [2,5]

earthquakes and compared the results to the respective mapped land damage observations. The results showed that Boulanger and Idriss [23] gives the most consistent distribution of calculated LSN values between events for the observation categories of none-to-minor liquefaction-induced land damage and moderate-to-severe liquefaction-induced land damage. The LSN and land damage datasets for the CES events were combined into a single frequency bar chart shown in Fig. 3. This figure shows that at low estimated LSN values there is a high likelihood of none-to-minor land damage and a low likelihood of moderate-to-severe land damage. Conversely, at high LSN values there is a low likelihood of none-to-minor land damage and a high likelihood of moderate-to-severe land damage.

The interpolated LSN values shown in Fig. 5 were spatially matched with pipelines and repairs by using GIS to correlate LSN values with the pipelines and repairs. To be consistent with the LSN range given in Fig. 3, LSN intervals of 10 were used, and the screening criterion described by O'Rourke et al. [11] was used to produce meaningful correlations. The total length of pipelines in the area of interpolated LSN values is 490 km and distribution of pipelines with respect to pipe types are: 216 km AC, 80 km CI, 73 km PVC, 29 km MPVC and 92 km other types (steel, concrete, ductile iron etc.). A total 1,179 repairs were undertaken within the area of interpolated LSN values and nearly 90% of these repairs were AC, CI and PVC.

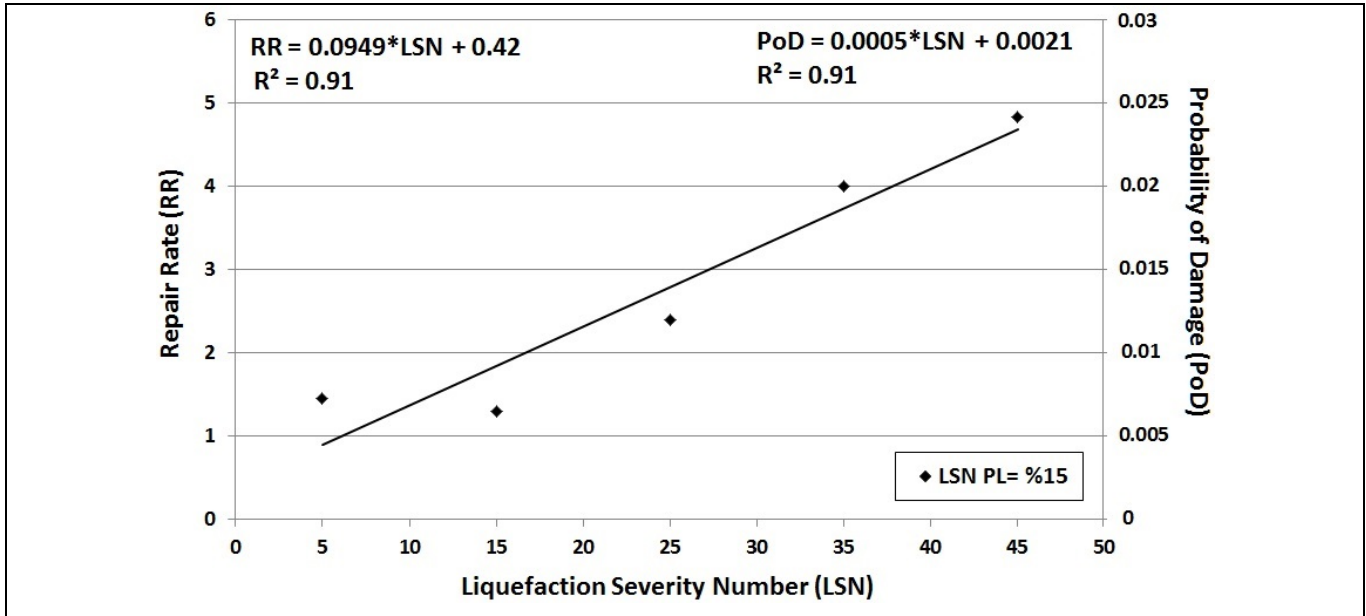
Fig. 7 RR and probability of damage vs. LSN relationships for CI pipelines

Figs. 6, 7, and 8 present RR versus LSN data for Christchurch and 22 February 2011 earthquake. The linear regressions and equations are shown in the figures for AC, CI and PVC water pipelines. Also shown in the figures are the Probabilities of Damage (PoD) for the pipelines. Correlations of RR for different pipe types vs. LSN were developed by counting the number of repairs and pipeline lengths for the particular pipe type in each LSN zone interval, and then calculating the RR associated with LSN intervals of 10. Using the screening technique described by O'Rourke et al. [11], 90% confidence and  $\alpha = 50\%$ , were applied to develop the linear regressions between RR and LSN. Sufficient RR data for AC, CI, and PVC water pipelines that passed the screening process were available to develop the regressions in the figures.

By using these laying pipe lengths and the distribution of pipelines after and before 1940, equivalent pipe length for CI pipes is calculated as 5 m. The number of pipes in each LSN interval that needed repair is estimated by assuming that each repair corresponds to one damaged pipe. This assumption was substantiated by checking and confirming that the distances between repairs are greater than 6 m by using GIS. The pipeline damage ratio is simply the ratio of the number of damaged pipelines to the total number of pipelines in the same strain category zone. Toprak et al [13] presented similar parameters, referred to as probabilities of damage, for AC and CI pipelines in Avonside area in Christchurch as a function of PGD (i.e. lateral stain and vertical angular distortion).
